## ALERT SERVICE BULLETIN

# Checking of the cylinder head assy. 2/3 for ROTAX® Engine Type 912 and 914 (Series)

This ASB revises ASB-912-062UL/ASB-914-044UL Initial issue

ATA System: 72-30-00 Cylinder head

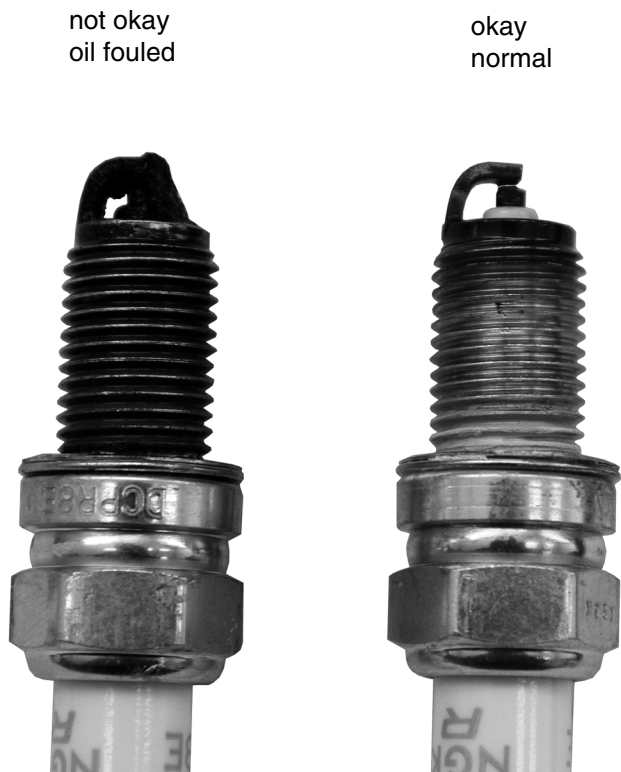
Fig. 1  
spark plug

Due to a deviation in the manufacturing process some cylinder heads may have an oil leak in the intake channel in the area of the valve guide. There is a possibility of small machined through holes, which can increase the oil consumption which may result in an engine stoppage.

NOTE: Unusual deposits (excessive carbon or oil) on the spark plugs are an indication of a defective cylinder head which must be replaced. Figure 1 shows comparison between a used spark plug in normal condition and one that is not.

Affected spark plugs with such deposits shown in chapter 4 Fig. 1, have to be removed and can not be reinstalled.

If excessive deposits (oil or carbon) are found on the spark plugs the cylinder head must be replaced in accordance with the relevant Maintenance Manual (Heavy) and any relevant aircraft manufacturer instructions.
