CHECKING OF THE CRANKSHAFT JOURNAL (POWER TAKE OFF SIDE) FOR ROTAX® ENGINE TYPE 912 AND 914 (SERIES)

ASB-912-059UL

ASB-914-042UL

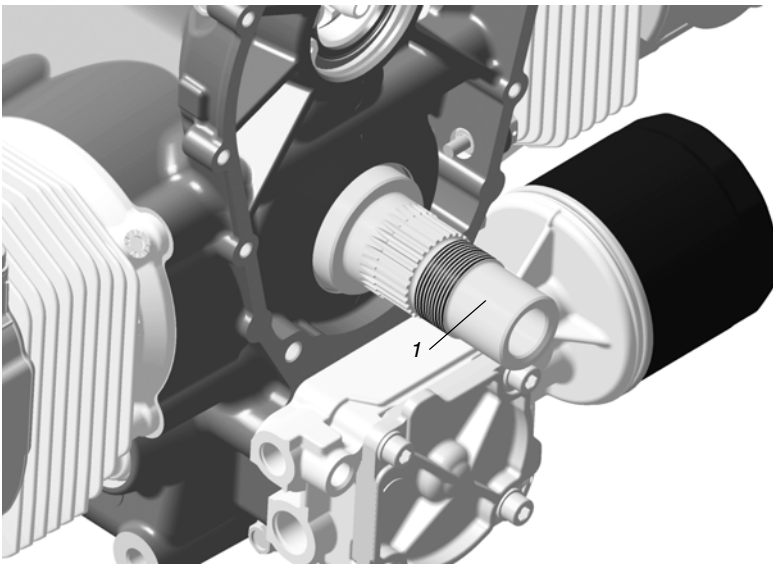
Fig. 1
crankshaft journal

Due to a deviation in the manufacturing process some crankshafts may have a crack formation occur on the power take off side. These cracks can cause a breakage of the crankshaft support bearing and may lead to engine stoppage.

- Detailed crack detection in the area (2) of the thread runout using penetration test. Perform this test in accordance to the requirements of the applicable aviation authority in your region for non destructive testing (NDT) and according to DIN EN 571 or equivalent.

- 1 crankshaft
- 2 detailed crack detection

- ◆ NOTE: Protect the crankcase against contamination by the test material.
 - CAUTION: In case of crack or doubt contact your aircraft manufacturer and your nearest authorized ROTAX aircraft engine distributor. The engine must not be taken into operation until the cause has been identified and eliminated.

7. If no cracks can be found, then the reassembly has to be conducted in accordance with following steps:
 - Lock the crankshaft in accordance with the relevant Maintenance Manual (Line).

- Clean and degrease crankshaft journal, threads and splines.
 - Install the drive gear with a new friction washer in accordance with the relevant Maintenance Manual (Heavy).
