SERVICE BULLETIN

Periodic inspection of the float buoyancy for ROTAX® Engine Type 912 and 914 (Series)

ATA System: 73-00-00 Fuel system

MANDATORY

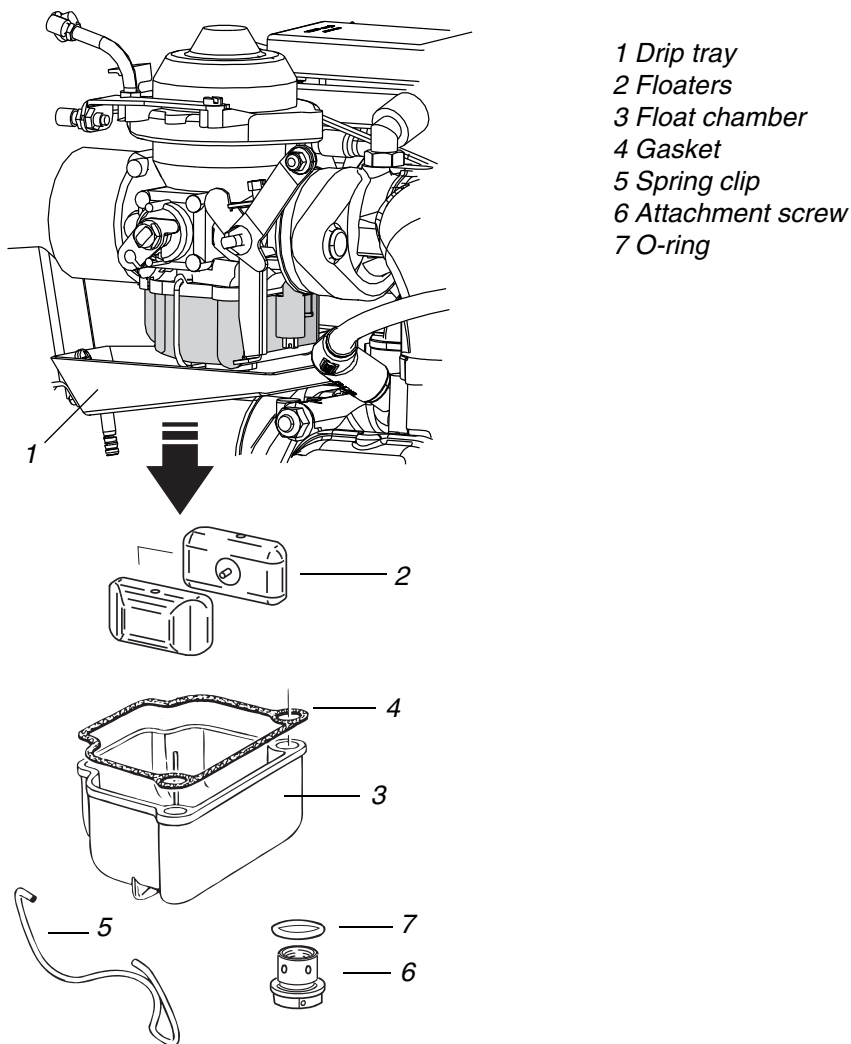
Fig. 4

If the inspection of float buoyancy section 3.5) shows a deviation, a weight control according to section 3.2) is necessary. For this purpose, as described below, the float chamber has to be dismantled.

Step	Procedure
1	Let the floaters dry for 1-2 minutes. Only balance dry floaters.
2	Check the weight of all affected floaters using a calibrated balance (1). Measuring tolerance of the balance: max. 0.1 grams.
3	The results of the measurement must be documented in the maintenance records. The max. allowable weight (of both floaters) is 7 grams.

Renew all floaters which exceed the max. weight.
