CHECKING OF MAGNETIC PLUG

ON ROTAX® ENGINE TYPE 912/914 (SERIES)

SB-912-051

SB-914-034

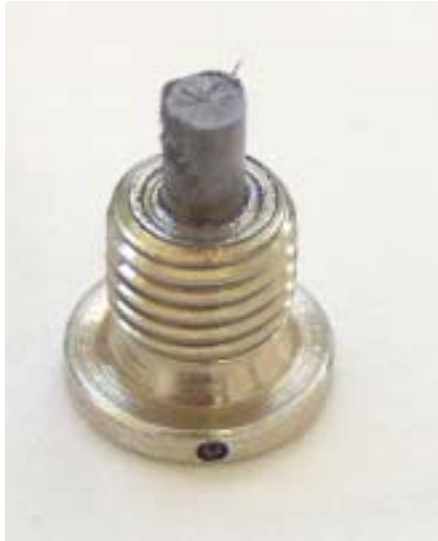
acceptable

See fig. 1 and fig. 2

1. Remove the magnetic plug according to relevant Maintenance Manual.

2. Inspect magnetic plug in accordance with procedure in relevant Maintenance Manual.
