SERVICE BULLETIN

Periodic inspection of the float buoyancy for ROTAX® Engine Type 912 and 914 (Series)

ATA System: 73-00-00 Fuel system

MANDATORY

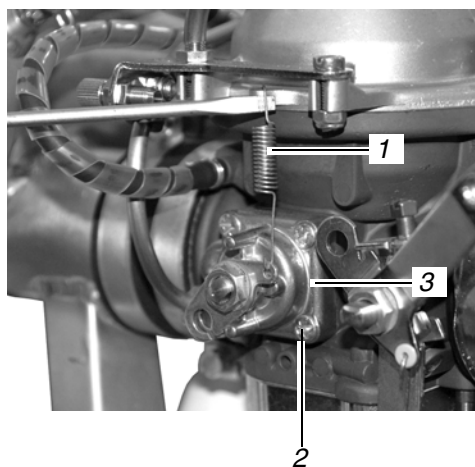
Fig. 1

- 1 Return spring
- 2 Philips head screw M4x14
- 3 Rotary valve housing
- 4 Air vent line

Step	Procedure
1	Bring the float chamber to horizontal position (level the aircraft, if necessary).
2	Let the engine idle for approx. 1-2 minutes. NOTE: Switch OFF the electric fuel pump (at 912 Series).
3	Remove the return spring (1).
4	Remove 4 Philips head screws (2). Remove rotary valve housing (3) with the gasket.
5	Remove the air vent line (4). Installed steel line must not be removed.

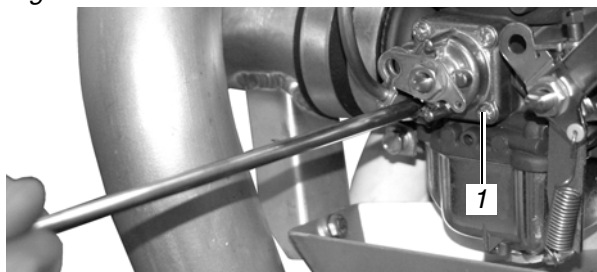
Fig. 3

1 Philips head screw 4x14
2 Return spring

Step	Procedure
1	Install the venting line.
2	Install rotary valve with new gasket.
3	Secure first 2 threads of the Philips head screw 4x14 (1) with LOCTITE 243.
4	Install the return spring (2).
