SERVICE INSTRUCTION

RUNNING MODIFICATIONS ON

ROTAX ENGINE TYPE 912/914 (SERIES)

SI-912-020R9 SI-914-022R9

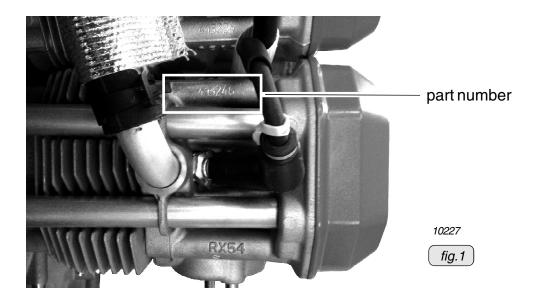
Step	Procedure					
1	Check the engine serial number S/N, if the aircraft is affected by this SI.					
2	Check of maintenance documentation if a repair or maintenance was performed on one of the cylinder heads.					
3	Check the part numbers of the cylinder heads. See fig.1.					
4	Check of the cockpit (indicating instruments) or the aircraft-specific manuals or consultation with the aircraft manufacturer or its service facilities if the coolant temperature or cylinder head temperature is displayed.					
5	The measurement position naming in the indicating instrument or the operating limit must be amended or corrected in consultation with the aircraft manufacturer, if necessary. See chapter 1.2.1).

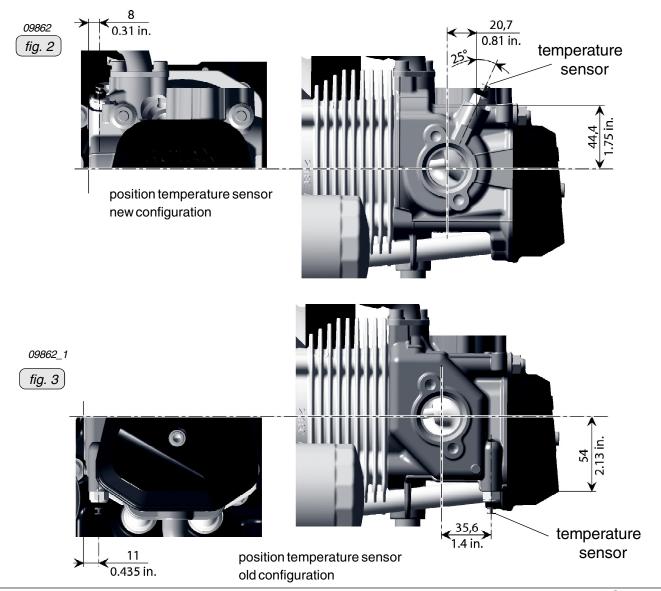
The following drawings should convey additional information:

◆ NOTE: Identifying of new cylinder heads: The electrical connection of the temperature sensor is pointing upwards. New configuration see fig. 2. Old configuration see fig. 3.

Regarding change of position of the temperature sensor, see fig. 2 and fig. 3.

(see fig. 2 and fig. 3)

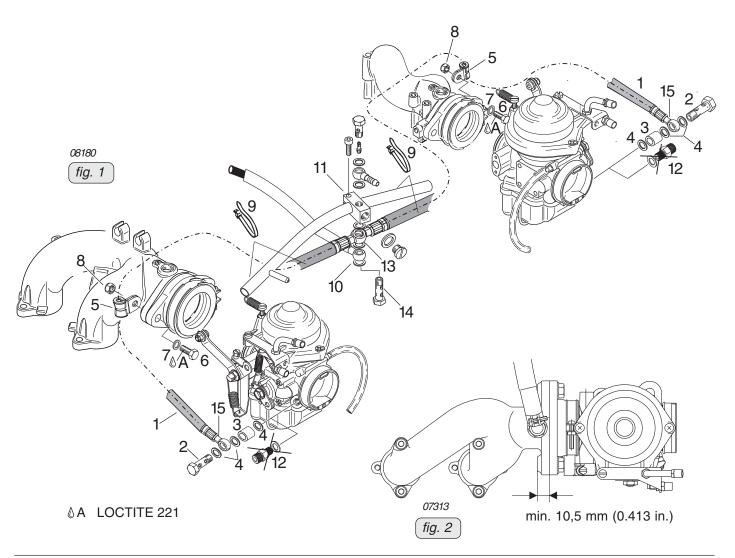
the following drawings should convey additional information:

- For installation on an old style intake manifold perform the following: Remove the intake manifold and machine the nut/clamp contact area until the surface is parallel with the sealing surface of the carb socket. The thickness of the material must not be dressed down less than 10,5 mm (0.413 in.) and should be smooth and flat so that the nut/clamp assembly has an even contact surface (see fig. 2).

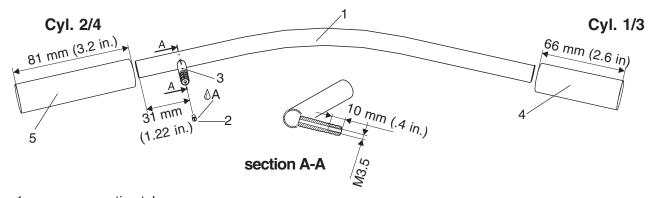
compensation tube part no. 924541

- 1 compensation tube
- 2 screw M3.5x6
- 3 connection fitting
- 4, 5 tube
- 6 hose clamp pliers
- 7 hex. screw M6x6
- 8

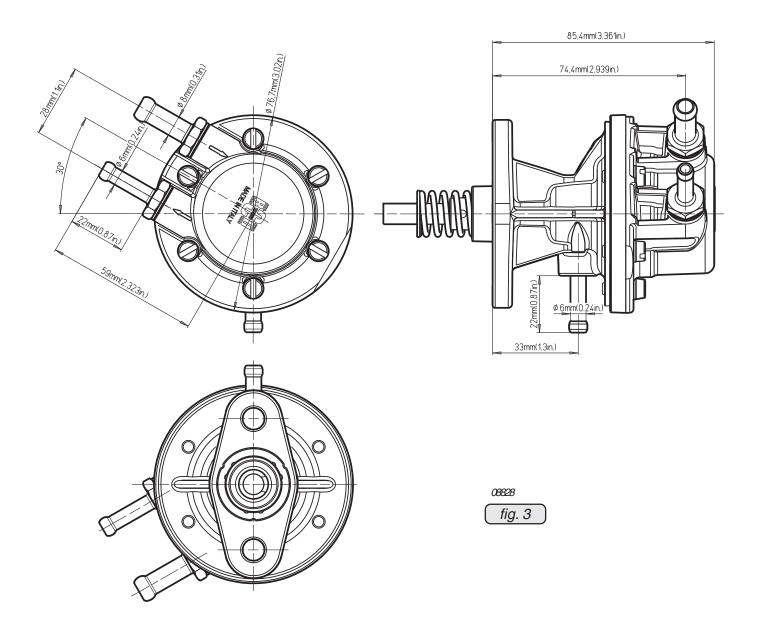
fuel pump assy. part no. 893110 Dimensions without tolerance \pm 0.3 mm (0.012 in.)

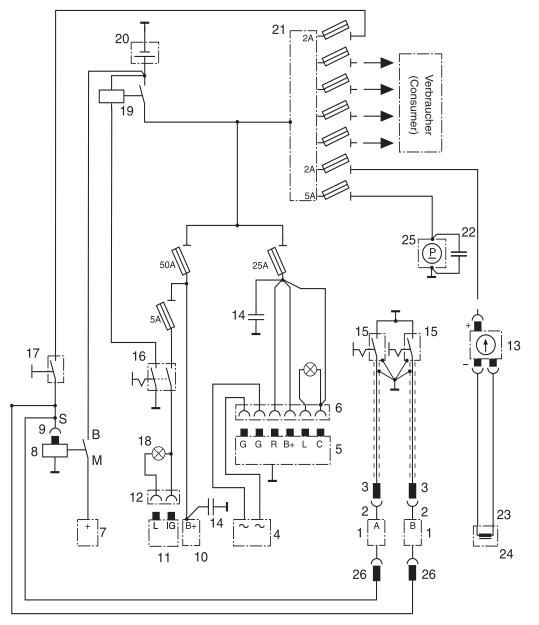
08673 fig. 2

В	battery
M	engine
S	signal
1	2 electronic modules (A and B)
2-3	plug connection for ignition switch
4	integrated generator
5-6	external regulator - rectifier with plug
	connections
7	electric starter
8-9	starter relay with plug connection
10-12	external alternator with connections
13	electric rev counter
14	capacitor

15	∠ ignition switches
16	master switch
17	starter button
18	control lamp
19	battery relay
20	battery
21	bus bar
22	capacitor
23	plug connection for trigger coil assy.
24	trigger coil assy. (tachometer)
25	electric fuel pump
26	starting equipment at the electronic

modules

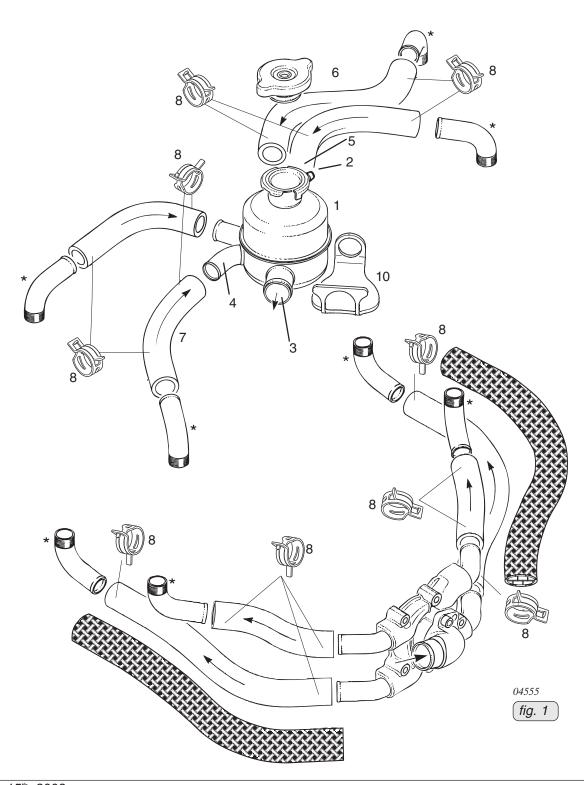
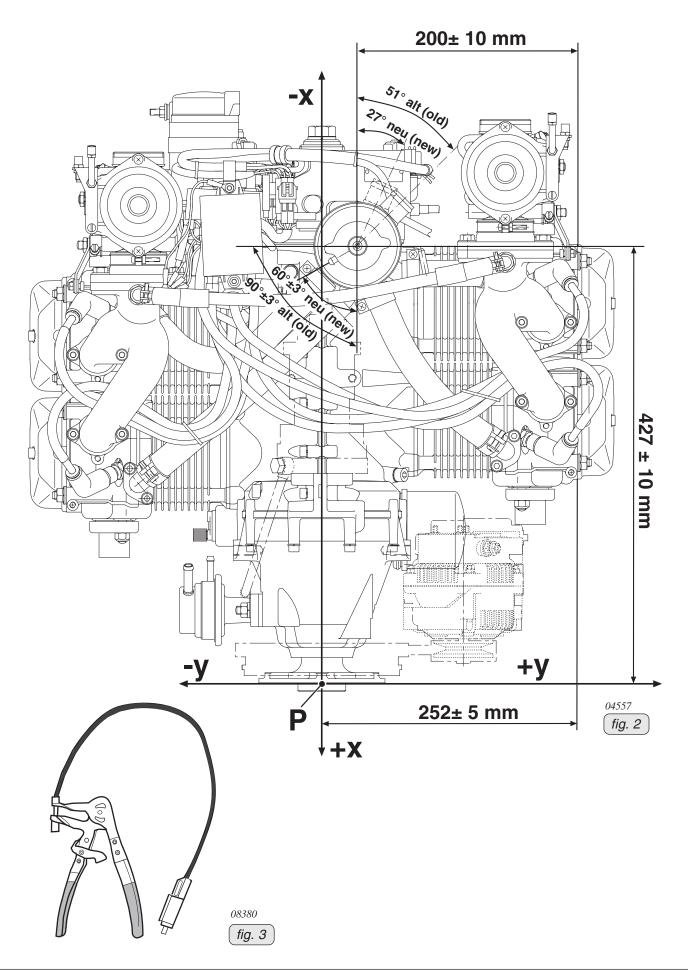
the following drawings should convey additional information:

^{*)} e.g. HAZET®, BERNER® or equivalent. See fig. 3.

- Install the coolant hose (6) 285 mm to cylinder 1 and the new coolant hose (7) 85 mm to cylinder 4. For attaching all the coolant hoses from expansion tank, water pump, cylinders, use the new spring type clamps.
- CAUTION: Take care of appropriate slip-on length of the coolant hoses on the corresponding connection socket. Verify tight fit of clamps and hoses and check for leakage. Always fit the clamps such that they can not wear on any component and use a suitable tool (see fig. 3) for fitting them.

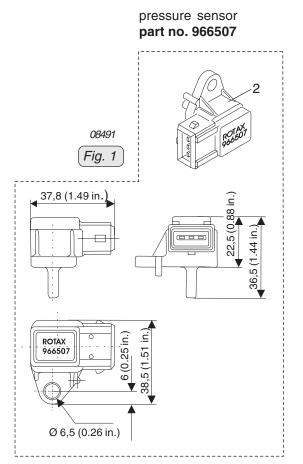
the following drawings should convey additional information:

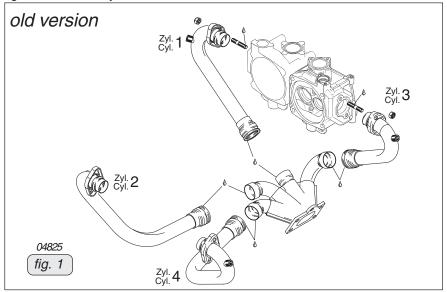
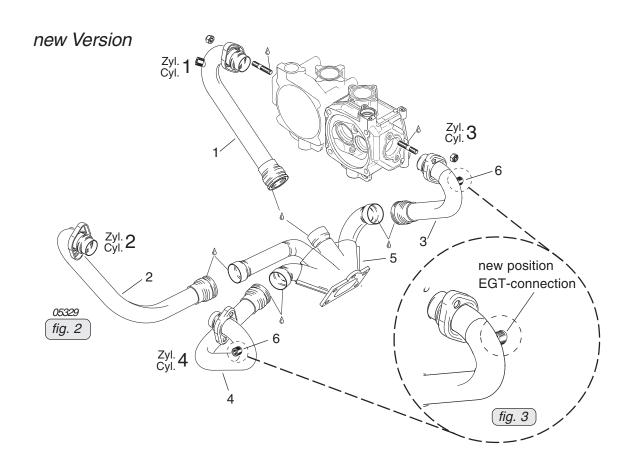
the following drawings should convey additional information:

Fig	New	Qty	Description	Old	application
item no	part no	per engine		part no	
1	979425	1	exhaust bend assy cyl. 1	979420/421/422	ROTAX _® 914
2	979435	1	exhaust bend assy cyl. 2	979430/431/432	ROTAX _® 914
3	979445	1	exhaust bend assy cyl. 3	979440/441/442	ROTAX _® 914
4	979455	1	exhaust bend assy cyl. 4	979450/451/452	ROTAX _® 914
5	979413	1	exhaust manifold	979411	ROTAX 914
•	NOTE:	If replace	ement of any single old part num	ber is necessary, yo	u must replace i

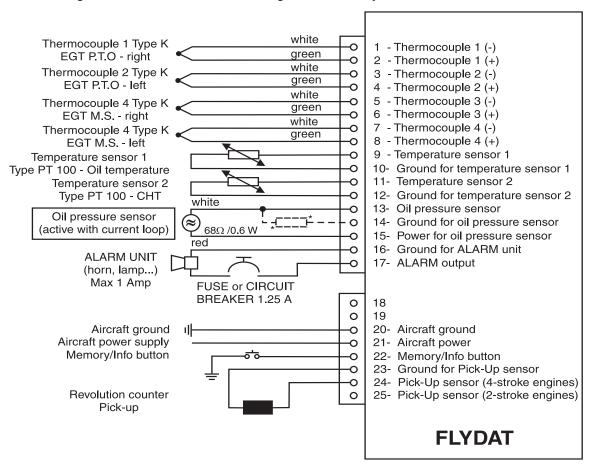
08446

the following sensor characteristic and drawings should convey additional information:

^{*} resistor is part of the retrofit kit for Flydat part no. 886857. See also 1.3.2.
