SERVICE LETTER
NON-APPROVED MODIFICATIONS OR
USE OF ROTAX[®] UNAPPROVED ENGINE
COMPONENTS OR ACCESSORIES
FOR ROTAX[®] AIRCRAFT ENGINES
SL-912-014
SL-914-012
SL-2ST-008

Non-approved modifications or use of ROTAX[®] unapproved engine components or accessories for ROTAX[®] aircraft engines.

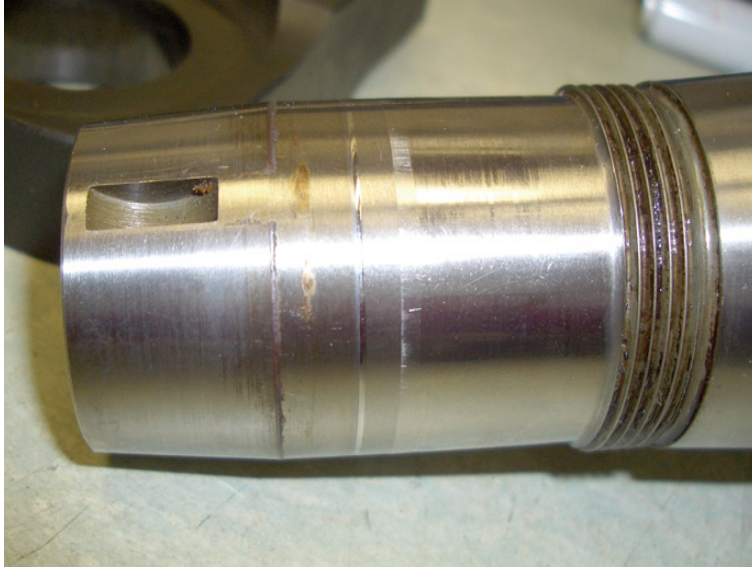
fig. 1

- The crankshaft has a ROTAX[®] part no. 888164 and a serial number (S/N) of S/N 11798, but was not marked as overhauled and shows some serious deficiencies:
 - signs of corrosion in the area of the oil seal (see fig. 1)
 - crankshaft was beyond the out of round limit
 - torque at twist test was below limit
 - a conrod bearing shows signs of wear (see fig. 2)
 - contamination in the oil channels (see fig. 3)

Such a crankshaft is not airworthy and should not be installed or any parts reused according to ROTAX[®]-instructions.

- Ensure before purchase the source and technical release of the part.
- For repaired and overhauled parts request the relevant report and take care that these are documented in accordance with ROTAX[®] instructions.
- For certified parts/engines request further on an Airworthiness Approval Tag.
